An In-Depth Assessment of Internal Contamination in the Wide Field/Planetary Camera

Carl Maag, Jerry Millard, and Mark Anderson
Jet Propulsion Laboratory, California Institute of Technology

By: Carl Maag*, Jerry Millard, and Mark Anderson
Jet Propulsion Laboratory
California Institute of Technology
Pasadena, California

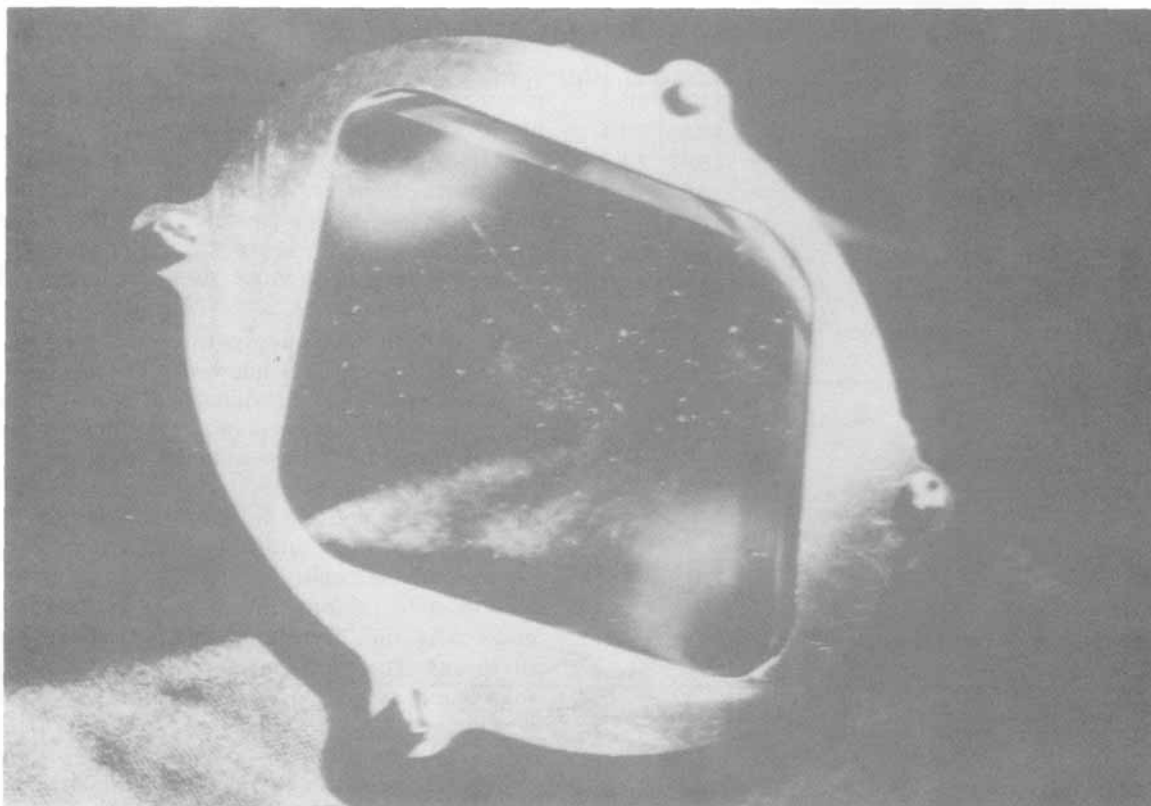
The WF/PC has been subjected to six system-level thermal vacuum tests at the Jet Propulsion Laboratory (JPL) and one at the Lockheed Missile and Space Company, Inc. (LMSC) while installed in the HST. Following the test at LMSC, a gray haze was discovered on two corners of the WF/PC aperture window. Figure 2 shows the extent of the deposition. At the time of notation, it was not possible to determine if the haze was on the inside or outside of the aperture window. A

Figure 2. Window in retaining cap showing molecular contamination pattern.

Figure 2 is the best single photograph of the contamination pattern on the inside of the window. A careful study of several photographs revealed the true extent of the contamination. The entire exposed surface of the window was contaminated. Two corners of the window received the most extensive deposition (a corner is defined as the region in the vicinity of the window retaining cap curvature). A window-wide pattern to the contamination exists. The most extensively contaminated corners are those closest to the hinges. Here, the contamination approaches a maximum. The least contamination occurs in the corners farthest from the hinges.

It should be noted that in the immediate corners there is less contamination than in the region around the corners (the image of a "baseball field" pattern is seen in the most contaminated corners in Figure 2.) A wide, sloping ridge of relatively moderate contamination tends to extend out from the most extensively contaminated

Although similar, the two most extensively contaminated corners do not have identical patterns (i.e., one corner may be contaminated more than another). This overall deposition pattern suggests the contamination source is relatively close to the window within the housing enclosure.

The mechanical cover was later subjected to a 45°C (113°F) bakeout using two temperature-controlled quartz crystal microbalances (TQCMs) to monitor any additional outgassing. The bakeout continued for 45 days at which time the data from the TQCMs suggested all outgassing had decreased to an acceptable level (i.e., less than the established requirement).

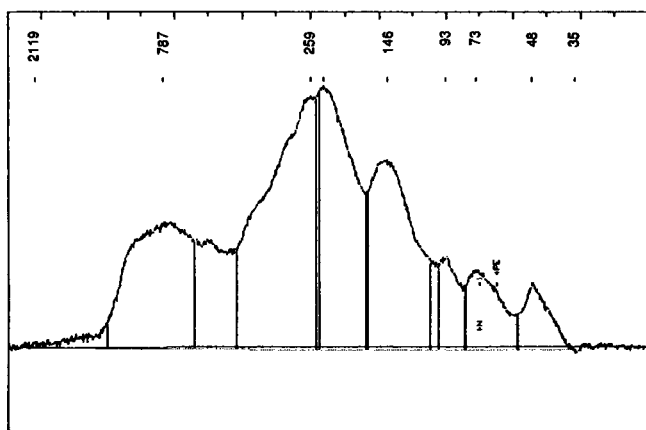
The rinse solution was then analyzed by gel permeation chromatography. This technique separates unknowns into peaks, depending on molecular size. From this, the molecular weight can be estimated. The chromatographic analysis showed that the haze was a complex mixture with a broad molecular weight distribution (see Figure 3).

Figure 3. Molecular weight chromatogram.

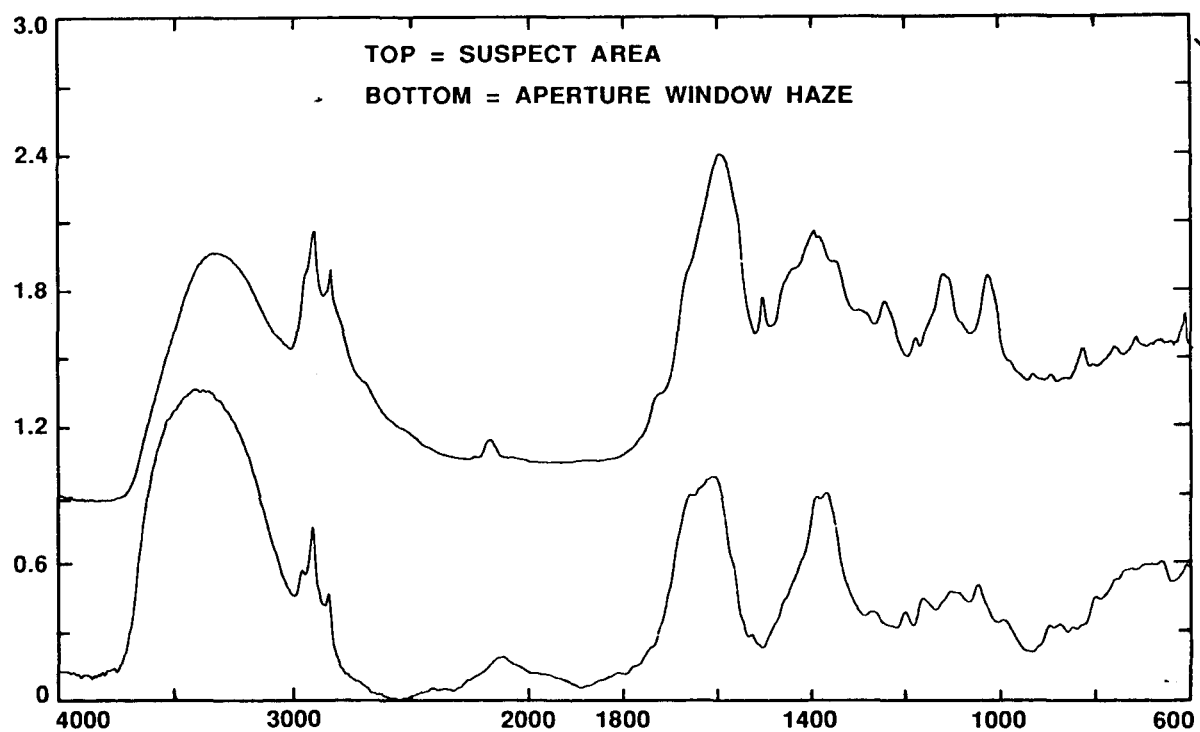
In this method, the sample is evaporated from a solvent onto an infrared transparent, finely divided, potassium chloride powder. This provides a matrix that allows multiple reflections of infrared radiation through the sample and increases the sensitivity of the FTIR spectrometer. This method provided an excellent infrared spectrum of the aperture window contamination (see Figure 4).

Figure 4. FTIR spectra.

The two infrared spectra (See Figure 4) show the same major organic functional groups present, and samples to be of similar mixtures. The organic functional groups of amine, aliphatic, and hydroxyl predominate the spectra. This is consistent with the fact that the Stycast bonding material is an aliphatic amine cured epoxy.

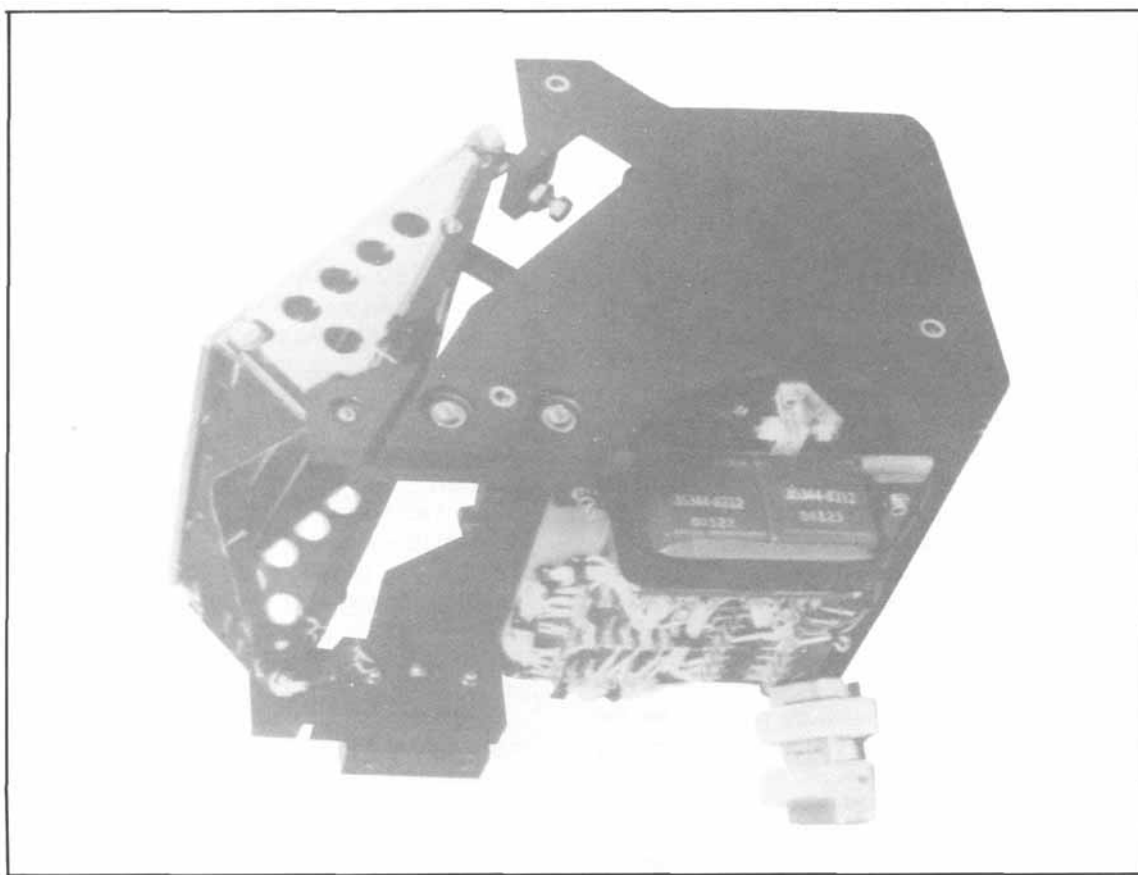
The QEH mirror mechanism shown in Figure 5 required a modification late in the hardware flow that precluded an additional bakeout of the structure. This modification consisted of the addition of the optics installation and a fracture control modification. The optics installation operation used a very small quantity of room temperature vulcanizing silicone (RTV) to

The leading candidate materials were the Stycast adhesive and the lanyard material used at the hinge points of the flip-mirror assembly (see Figure 5). The flip-mirror is to the left, and the controlling mechanism to the right. The hinges are in the foreground. On the lower hinge, the white lanyard material is held in place by wire and dark Stycast adhesive. Although not visible, the same is true for the top hinge.

Figure 5. Flip-mirror assembly with hinges in foreground.

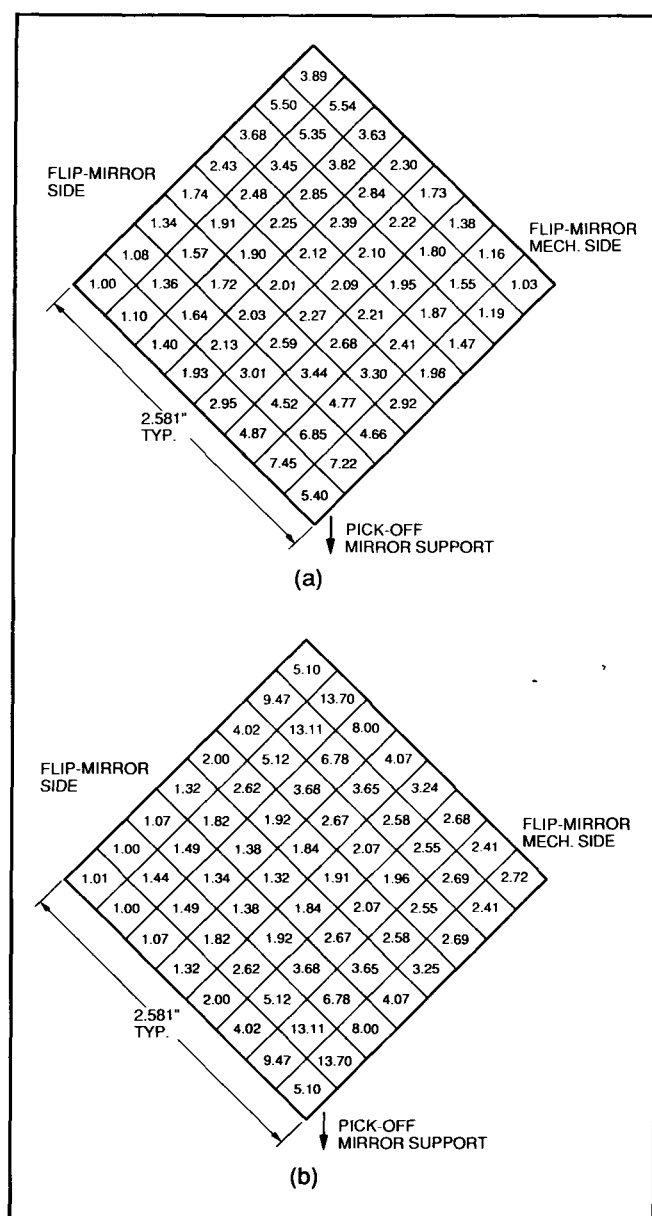
The resulting normalized deposition patterns on the window are shown in Figure 8. These results are presented individually for the Stycast adhesive (a) and the lanyard material (b). In both cases, the entire window experiences deposition.

also show the pattern of being the highest near the top and bottom corners, decreasing slightly in these corners. The side corner regions display the lowest values. In addition, there is a ridge formation in the vertical pattern which peaks far to the mechanism side of the window. These results show a deposition variation over the surface of the window of approximately a factor of 13.7.

The results for the Stycast adhesive are similar, except the ridge tends to be less skewed to the mechanism side and has a trend up the middle of the window. In addition, the distribution is not symmetrical about the horizontal centerline. Instead, it tends to be moderately biased toward the lower half of the window. These results show a deposition variation over the window surface of approximately a factor of 7.5.

A careful qualitative comparison of the results for each material with the actual pattern from the photographs suggests the Stycast adhesive is the dominant source of deposition. The analytic results for this material match the pattern significantly better than the lanyard results.

Figure 8. Analytical deposition pattern on window from: (a) Stycast adhesive outgassing, (b) Lanyard outgassing.
