# *Columbia* Accident Investigation and Return-to-Flight Effort

By Matthew E. Melis; Mike Pereira, PhD; Duane Revilock; and Kelly S. Carney, PhD  
NASA Glenn Research Center

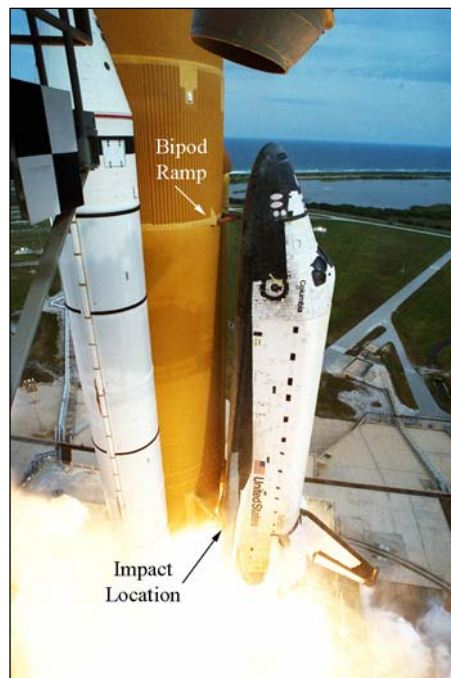
The orbiter is attached to the ET at three locations: two support points at the rear of the vehicle and one at the front, referred to as the bipod. The bipod consists of two struts connecting the front of the orbiter to the ET. The bipod attachment at the ET requires additional insulation applied by hand in the shape of a ramp to optimize its aerodynamics. This foam build-up is referred to as the bipod ramp. Figure 2 highlights the bipod, the bipod ramp, and the general impact location on *Columbia*'s left wing leading edge.

**Figure 2.** Shuttle *Columbia* just after liftoff showing the bipod attachment, the bipod ramp, and the location of impact.

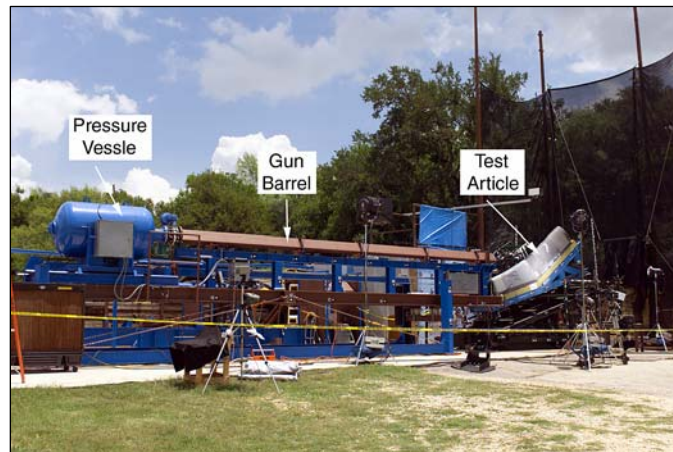
Little was known at the time of the accident about the impact characteristics of either BX-250 or RCC. Once it was determined that ET foam debris from the bipod ramp was a likely cause of the leading edge breach, the CAIB began an aggressive test program at Southwest Research Institute (SwRI) in San Antonio, Texas, to build a full-scale test article of a segment of an orbiter leading edge for impact testing. RCC panels from the remaining orbiters that had similar mission histories to those on *Columbia* were used for the testing. Figure 4 shows the test range at SwRI with the full-scale test article (consisting of panels 5 through 10 with respective T-seals).

**Figure 4.** Ballistic test range at Southwest Research Institute shows gas gun and full-scale orbiter leading edge test article.

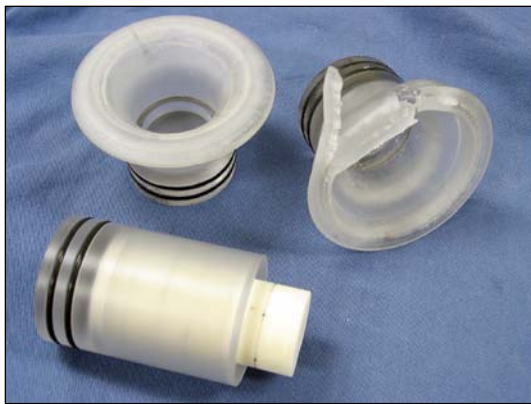
**Figure 5.** Polycarbonate sabots shown with BX-250 foam projectile in before and after fired condition.

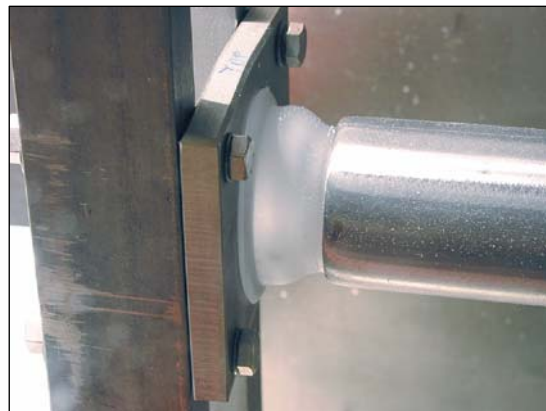
**Figure 6.** Sabot shown stopped at end of gun barrel. Note that O-rings remain inside barrel to maintain vacuum in the chamber.

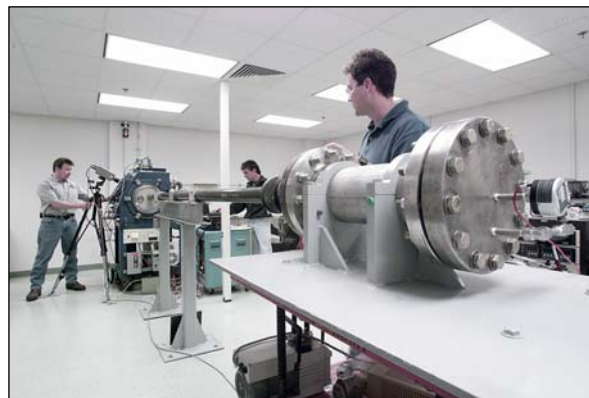
In the early stages of the accident investigation, it was determined that impact testing in a 1-psi environment on BX-250 foam would be necessary to validate the results of the full-scale testing. This capability did not exist within NASA so the GRC Ballistic Impact Laboratory team was directed to develop such capability. The challenge was to shoot 3.175-cm (1.25-in.) diameter  $\times$  7.62-cm (3-in.) long cylindrical foam projectiles at load cells in a vacuum chamber via a gas gun and restrict the propellant gasses from entering the chamber itself. This was accomplished through the use of sabots made of polycarbonate material, seated with two O-rings at the base. The sabots, seen in Figure 5, contain the foam projectile during the firing of the gun. At the end of the gun barrel, the sabot is stopped by a plate with a hole slightly larger than the projectile to stop the sabot yet allow the projectile to continue freely toward its target. The plate, or sabot stopper, is positioned such that the O-rings remain inside the barrel of the gun, thus containing the helium propellant from entering the vacuum chamber (Figure 6). The vacuum chamber impact test apparatus is shown in Figure 7.

**Figure 7.** GRC Ballistic Impact Lab small vacuum chamber test setup.

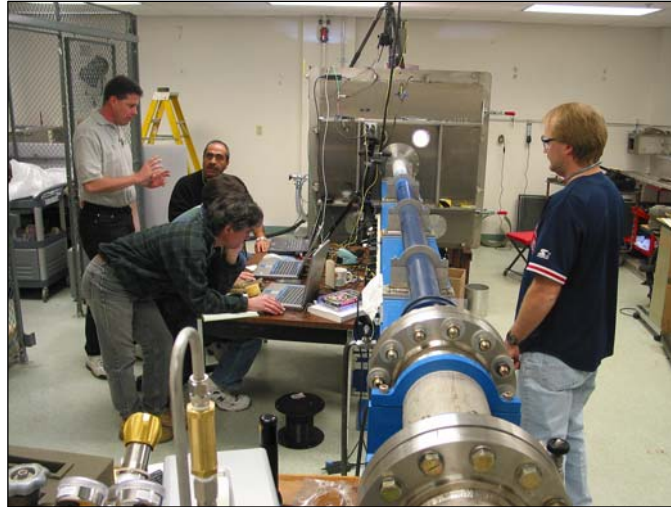
The majority of the tests for these programs were conducted in the GRC Ballistic Impact Lab's large vacuum chamber that was specifically built for the return-to-flight effort. The chamber, seen in Figure 10 with its 7.6-cm (3-in.) round barrel, has internal dimensions of 1.524 m × 1.219 m × 1.219 m (5 ft × 4 ft × 4 ft) and can accommodate a maximum barrel dimension of 15.2 cm (6 in.).

**Figure 10.** Large vacuum gun with 7.6-cm (3-in.) barrel in GRC Ballistic Impact Lab.

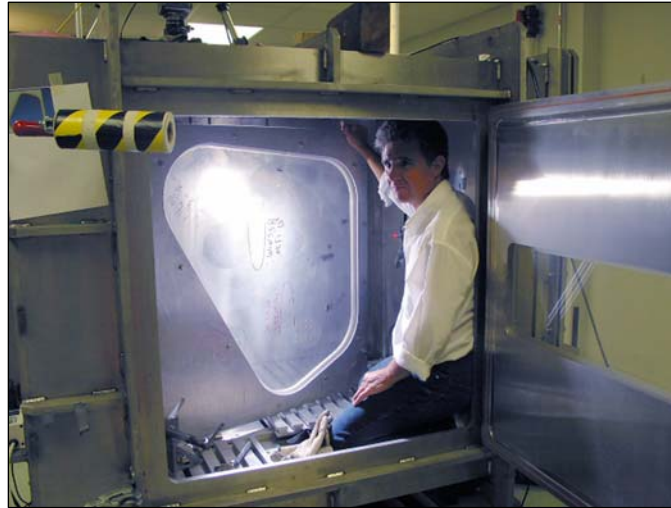
Foam, paper, and ice tests were performed in the GRC Ballistic Impact Lab's large vacuum chamber. Full-scale windows were mounted in an aluminum frame fixed inside the chamber at the prescribed angle to the gun barrel. Figure 14 shows a window mounted to the test frame inside the chamber in preparation for a test.

**Figure 14.** Orbiter window mounted in GRC Ballistic Impact Lab's large vacuum chamber in preparation for test.

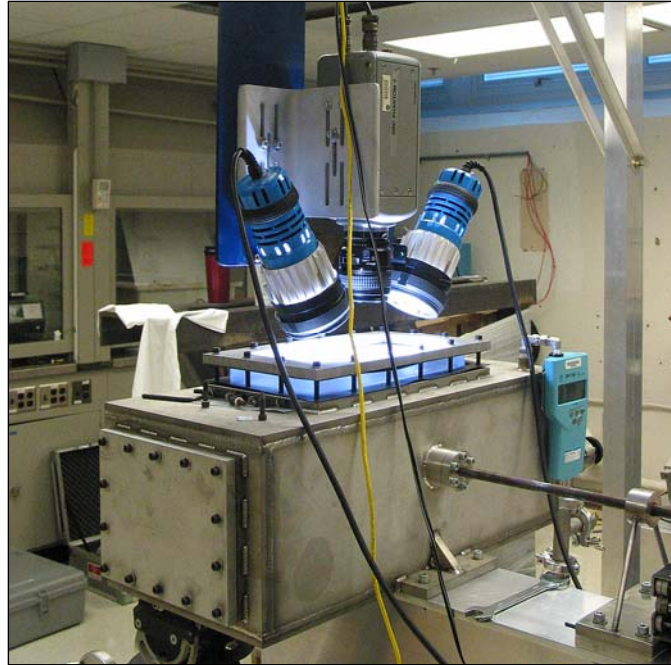
Aluminum oxide particulates of concern ranged from 100 to 450  $\mu\text{m}$  and were fired at the MOR bars using the 0.3175-cm (0.125-in.) vacuum gun. This setup, built specifically for this test series, is shown in Figure 15 with the external lighting system and the digital camera. Each window and MOR bar was fully inspected by certified Shuttle windows inspectors prior to testing to identify any preexisting damage to exclude in the post-test examination. Following each test, the windows were reexamined for any surface damage using a fiber-optic lighting system. Molded impressions were taken of any suspect damage sites and quantified with an optical comparator to establish whether the damage fell in or outside the acceptable safety limits.

**Figure 15.** The 0.3175-cm (0.125-in.) vacuum gun with digital camera and lighting system used to shoot 100-450  $\mu\text{m}$  particles at MOR bars.

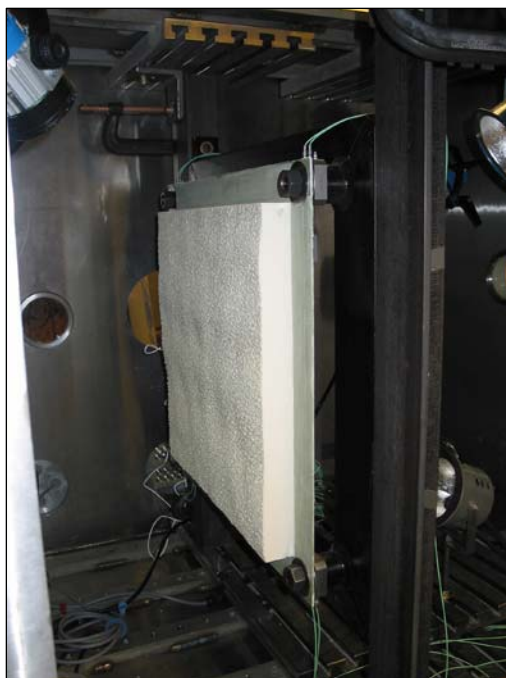
The DTA determined that ET BX-265, NCFI, or PDL foam debris could potentially shed and impact the tank downstream from the point of separation. Such an event might possibly result in significant TPS foam loss at the impact site that could put the launch system at risk. As with the windows, a variety of tests at varying angles, velocities, and projectile configurations were conducted at GRC to characterize TPS foam on foam impact. Target panels were made from 0.6096 m (2 ft)  $\times$  0.6096 m (2 ft) aluminum plates sprayed with approximately 2.54 cm (1 in.) of foam to represent actual coverage on the ET. The panels were mounted in the large vacuum chamber at each corner onto a load cell frame for measuring the force-time history of each impact. Figure 16 shows a panel mounted in the load frame in preparation for a 90° impact test.

**Figure 16.** Aluminum test panel with ET TPS foam mounted in large vacuum chamber load frame for 90° impact test.

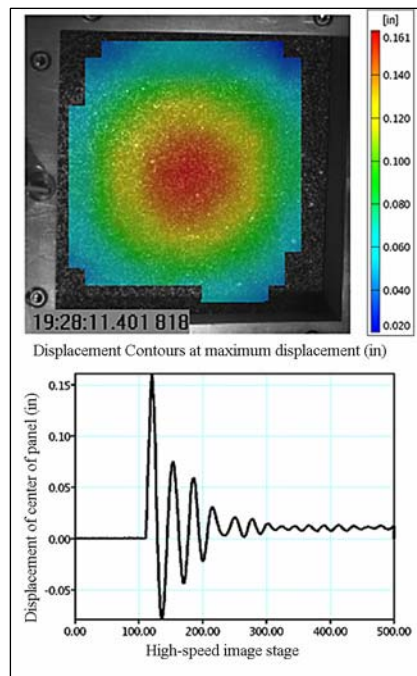
Of major significance for this test series was the method in which deformations were measured. A commercial full-field displacement measurement system utilized stereographic photogrammetry techniques to establish 3-D displacements at static and dynamic conditions.<sup>2,3</sup> The system, used in conjunction with two digital cameras to view the same field of interest from slightly different angles, correlated synchronized high-speed images from the cameras to compute 3-D displacements. Random speckle patterns painted on the surface being viewed insured correlation by the measurement system. While perhaps difficult to resolve in the back side panel images of Figure 17, this speckle pattern can be identified. Displacement measurements had good correlation with the code software predictions.

This accomplishment with the displacement measurement system using high-speed imagery was groundbreaking in nature and was of high value to the return-to-flight effort. The system was also used for the ET foam-on-foam impact tests in the same capacity as for the RCC panel tests. Figure 19 shows example output from one of the RCC panel tests depicting out-of-plane displacement contours and the time-displacement history of the center point of the panel.

**Figure 19.** Sample output from displacement measurement system depicting out-of-plane RCC panel displacement as it undergoes impact.
