An In-Depth Assessment of Internal Contamination in the Wide Field/Planetary Camera

Carl Maag, Jerry Millard, and Mark Anderson
Jet Propulsion Laboratory, California Institute of Technology

By: Carl Maag*, Jerry Millard, and Mark Anderson
Jet Propulsion Laboratory
California Institute of Technology
Pasadena, California

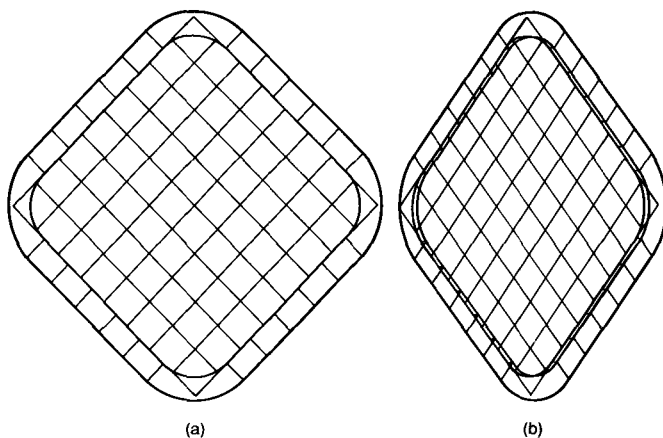
Figure 6. Internal view of window and retaining cap nodal model: (a) front view, (b) off-axis view.

Figure 6 shows a plot of the window and retaining cap nodal resolution with the window recessed slightly within the cap. Figure 7 shows a plot of the entire nodal model which illustrates the proximity of the geometry involved, especially the hinges with respect to the window.
